Environmental Analysis Associates, Inc.

Identifying HVAC system component corrosion and abrasion particles in indoor air quality samples

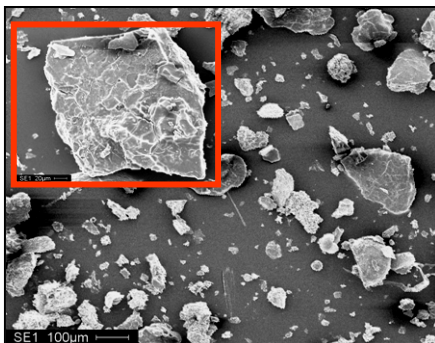
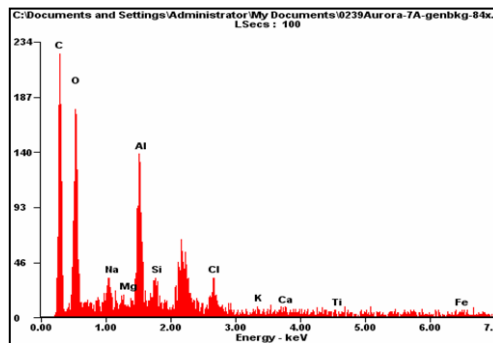
HVAC ducting corrosion :

Characteristic aluminum oxide particles derived from the oxidation and corrosion of metal ducting due to moisture exposure. (Note the presence of sodium & magnesium chloride salts)
